## INSPECTION REPORT

### A. FINAL INSPECTION REPORT: BY RDR

B. Project code : PBFNO  
Workshop : EQUIPROMEX  
Item : 682B.2/682H.2  
Drawing Nr : ASSY 100190354 Rev06, BODY 100190355 Rev04  
Order Nr : 2740  
PO nr : 2740  
Inspector : RODRIGO DIAZ  
Date : 06/29/2022

B. Project code : WORPAR  
Workshop : EQUIPROMEX  
Item : 622.2  
Drawing Nr : ASSY 100176100 Rev02, BODY 100176101 Rev02  
Order Nr : 2727  
PO nr : 2727  
Inspector : RODRIGO DIAZ  
Date : 06/29/2022

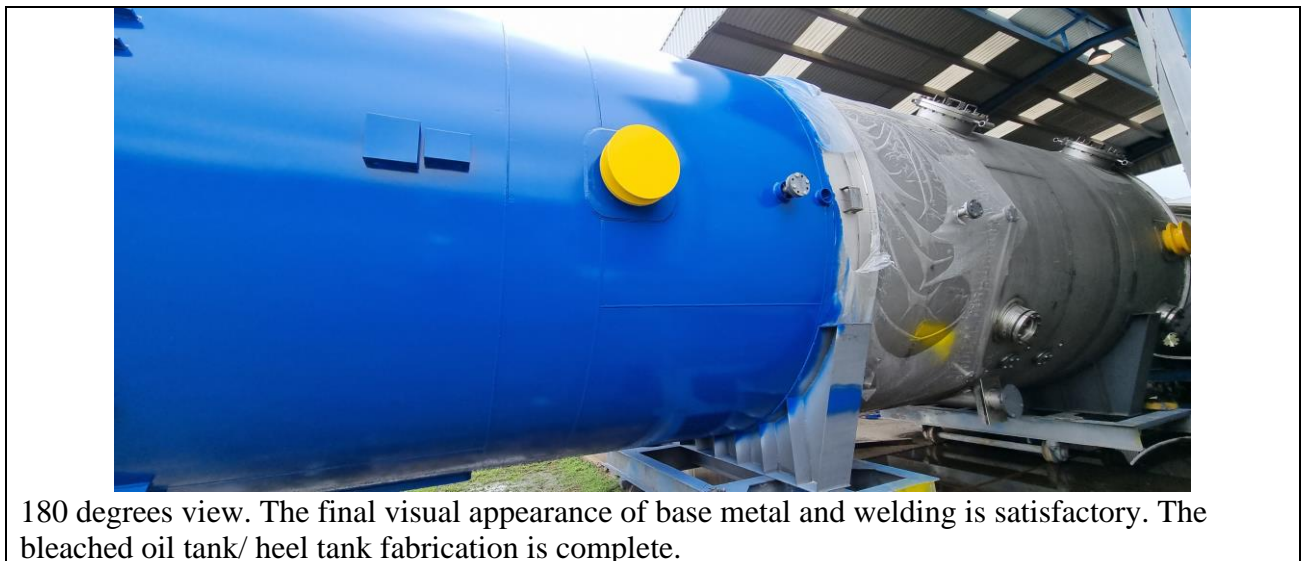
180 degrees view. The final visual appearance of base metal and welding is satisfactory. The bleached oil tank/ heel tank fabrication is complete.

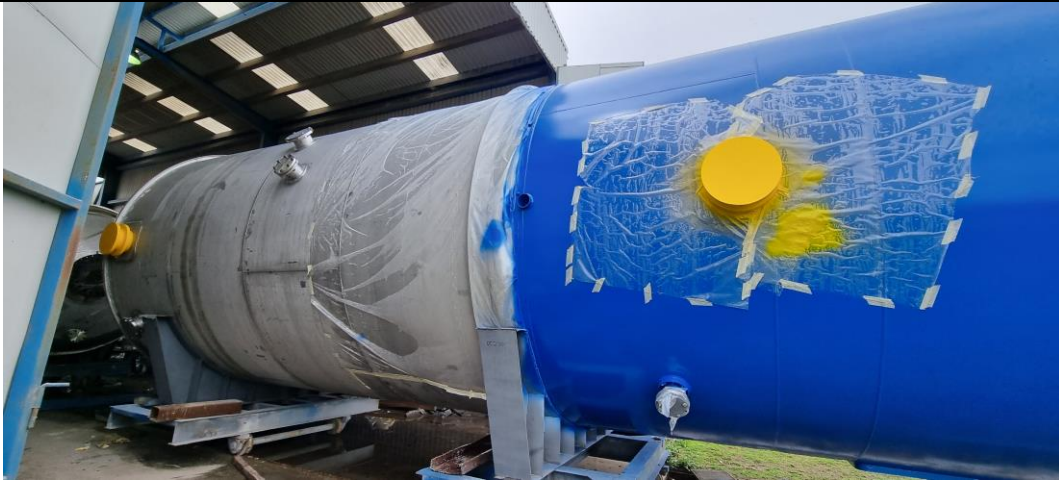
0-degree view. Shipment preparations are complete. Orientation and shipment marks painting is in process. Name plates to be attached.

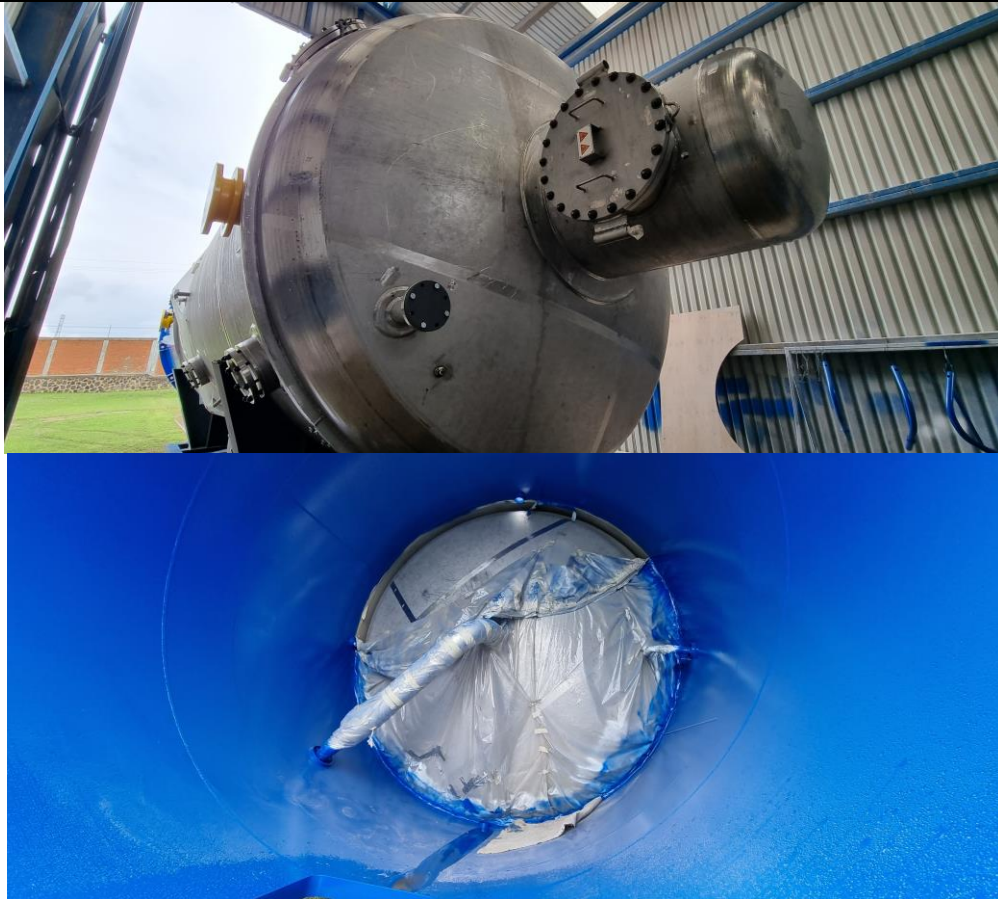
Dished ends. Final visual appearance is satisfactory. RX results on the welded seam are satisfactory. Thickness after forming is over 10.4MM.

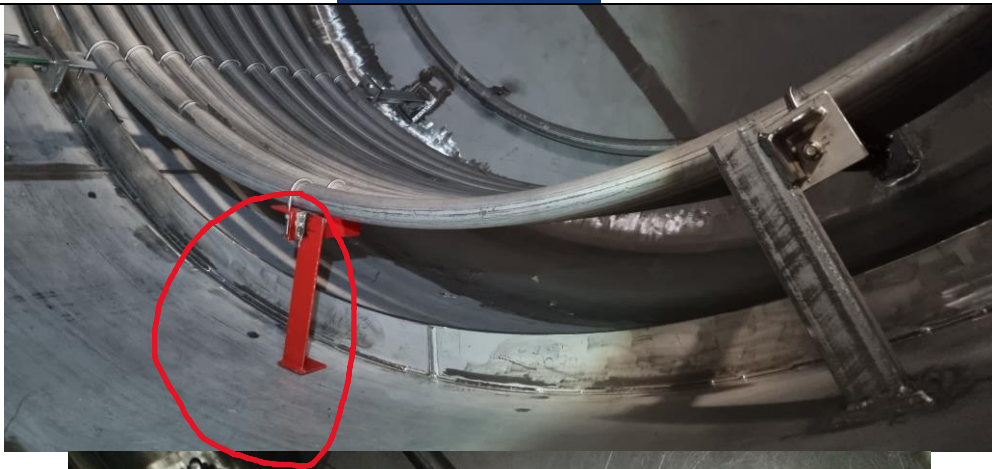
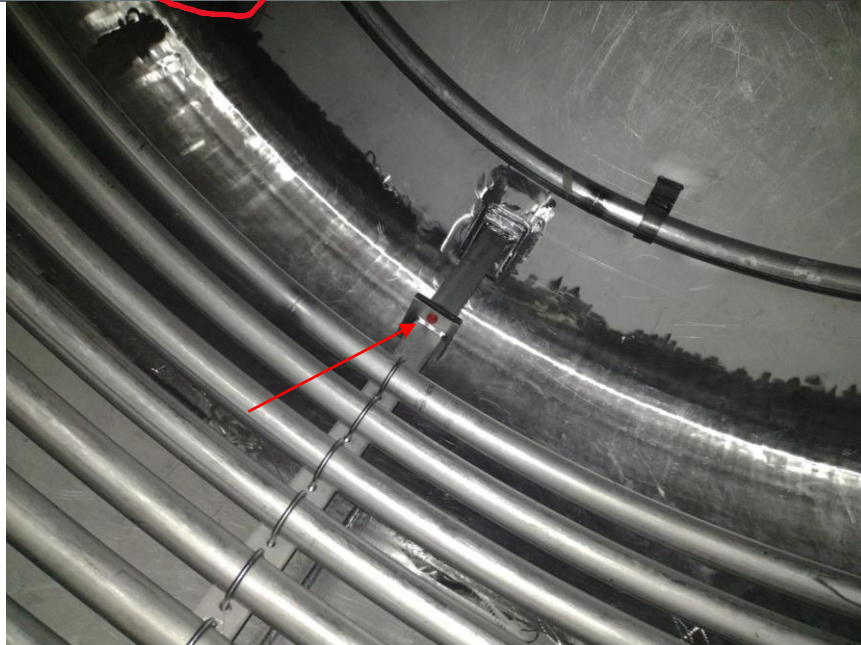
Coil's transportation supports and transportation bolts must be removed before vessel start-up.

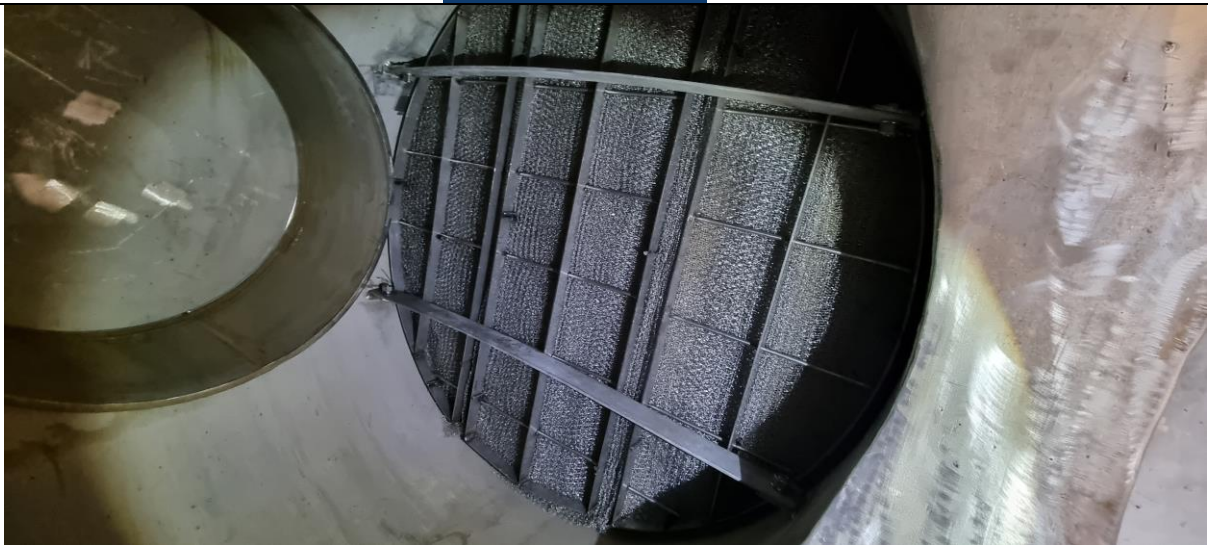
682B.2 Demister is installed.

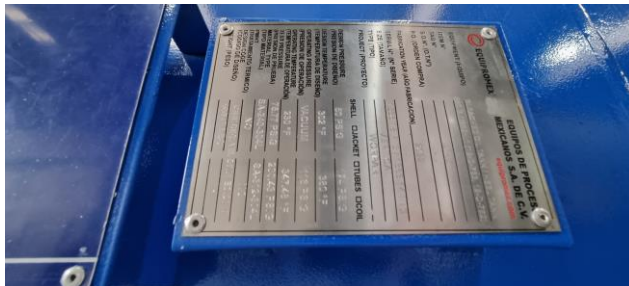
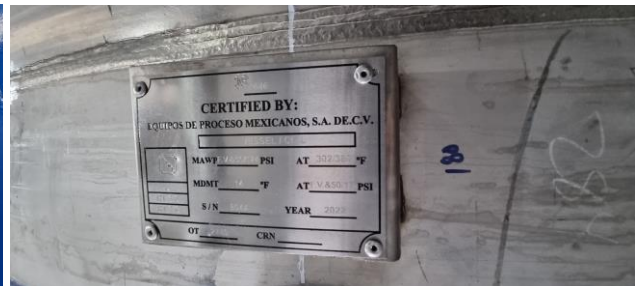
ASME plate and nameplate are properly attached. Both plates are with imperial units.

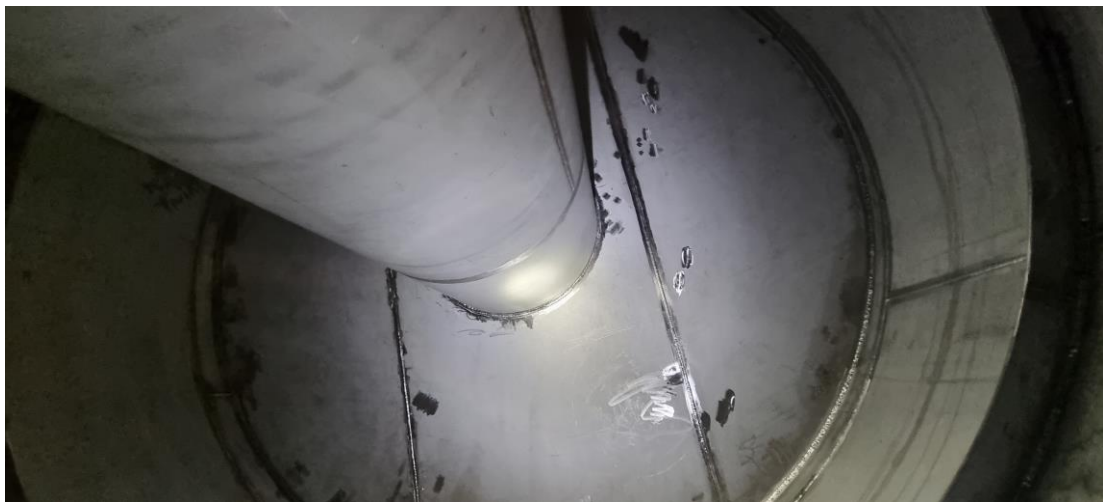
Section 682B.1 Performed internal visual inspection before the final test. The visual appearance of base metal and welding is satisfactory. Internal cleaning is ok.

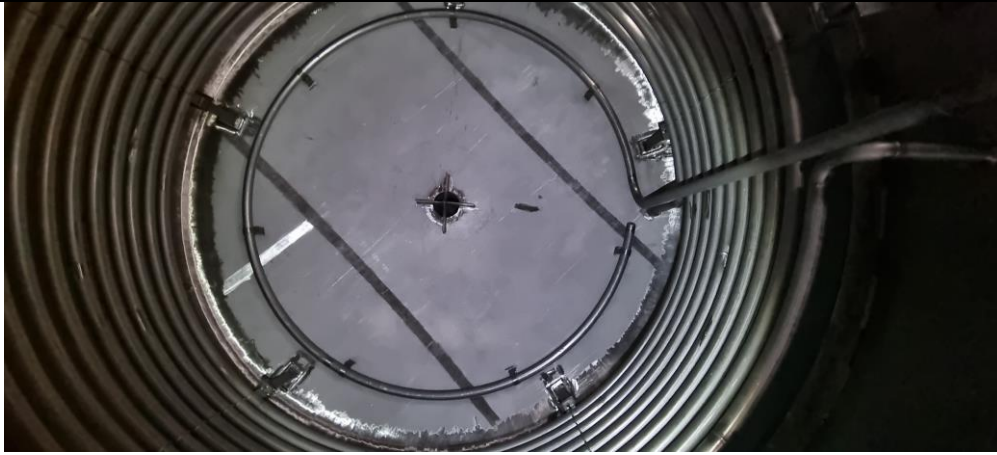
Section 682H.1 Performed internal visual inspection before the final test. The visual appearance of base metal and welding is satisfactory. Internal cleaning is ok.

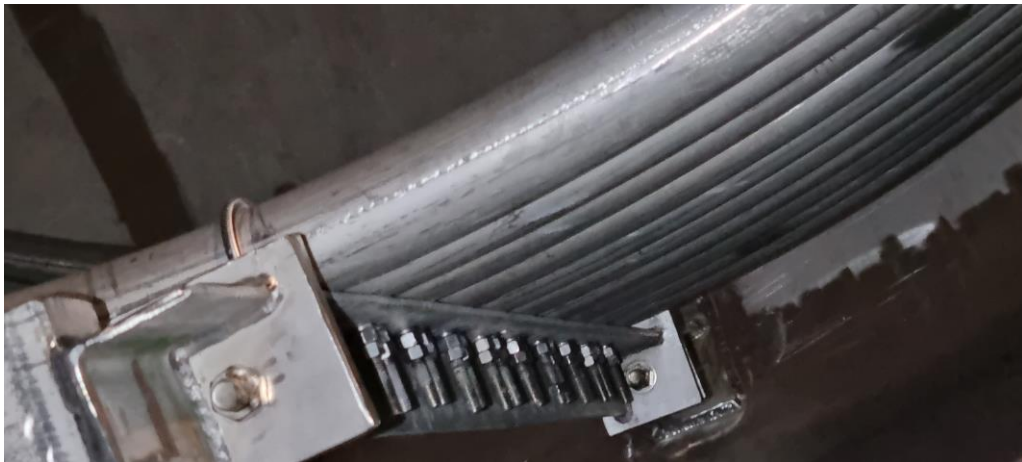
The coil is properly clamped.

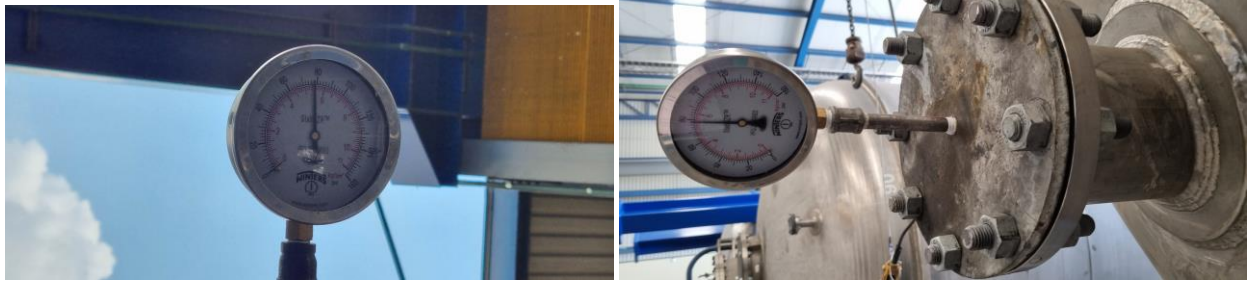
The vessel was hydrotested at 80 PSI. Both chambers were pressurized simultaneously without a maximum differential of 14.5 PSI. No leaks nor deformities were detected. The test was also approved by the ASME inspector.

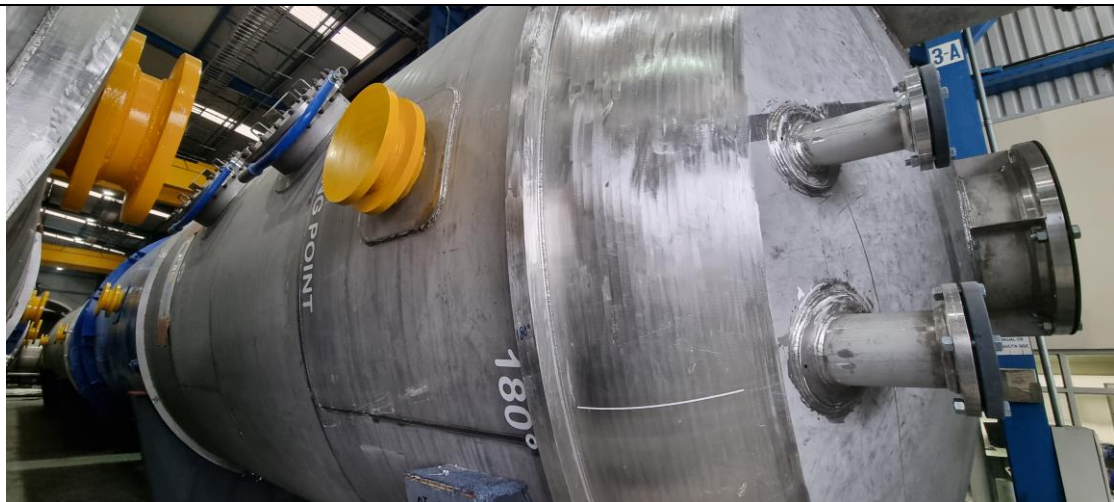
180 degrees view. Final visual appearance of base metal and welding satisfactory, external cleanness satisfactory. Bleacher 622.2 is ready for shipment.

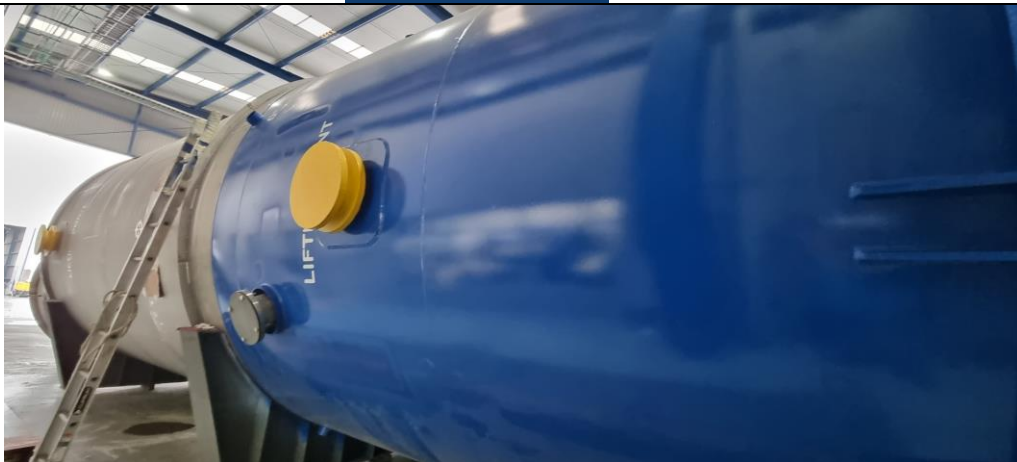
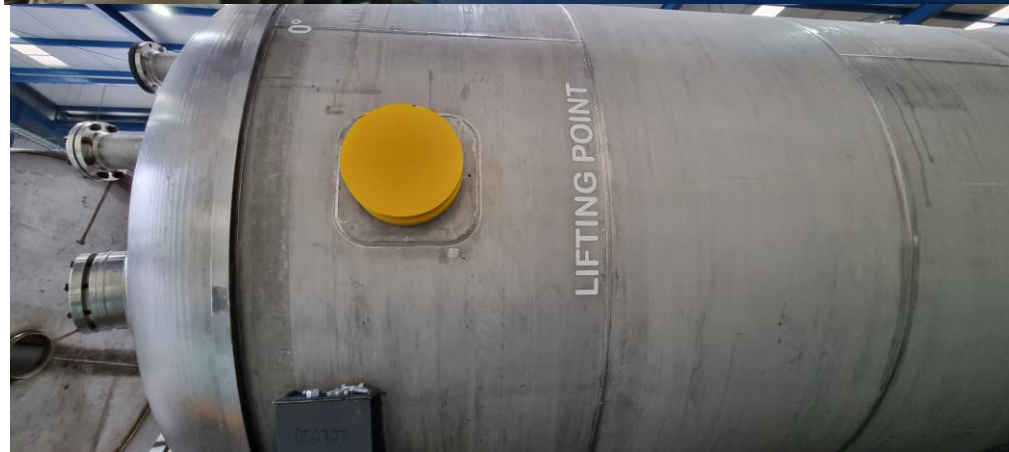
0 degree view. Shipment preparations are complete. Orientation and shipment marks are painted.

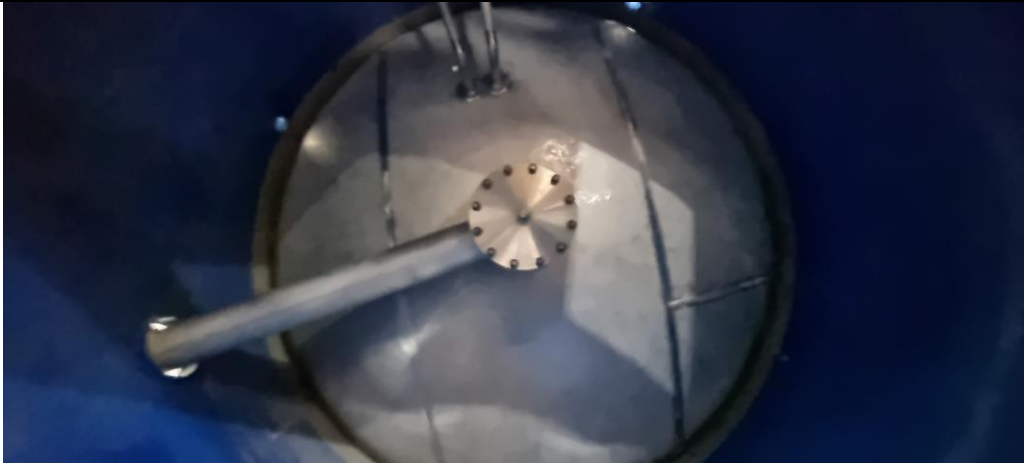
Dished ends. Final visual appearance satisfactory. RX results on the welded seam satisfactory. Thickness after forming is over 10.4MM.

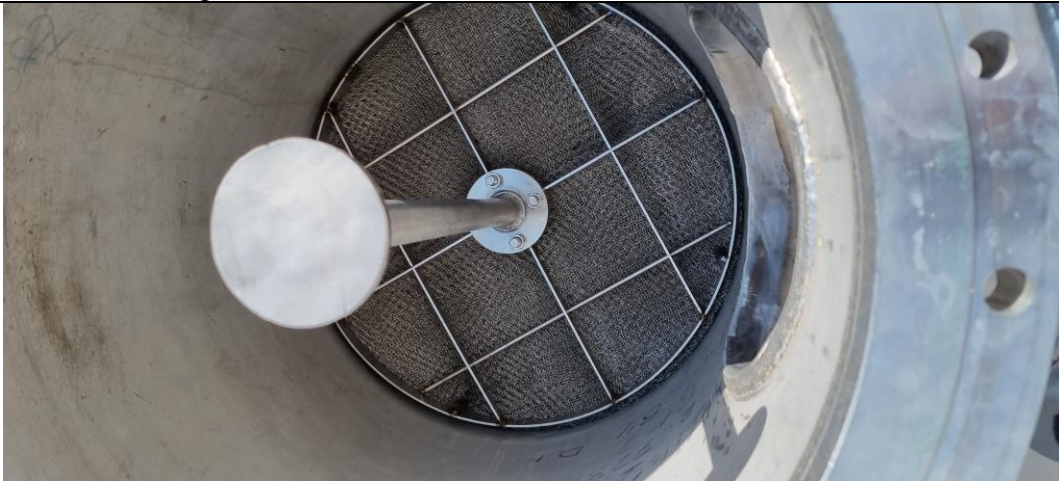
Fit up of mesh.

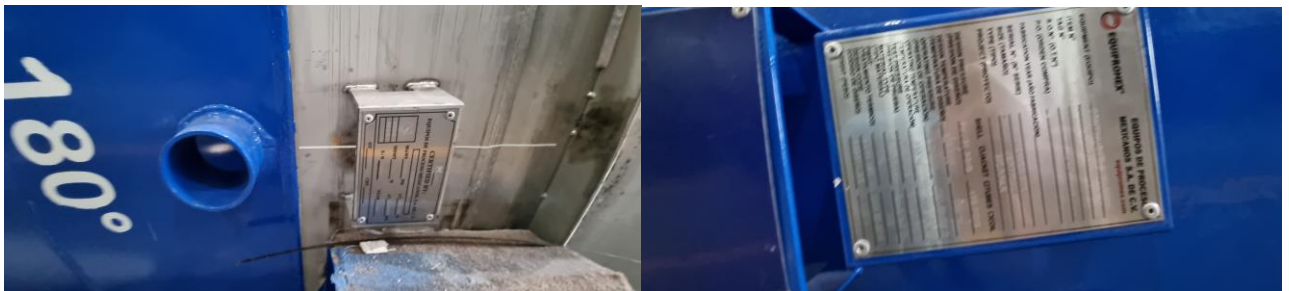
ASME plate and nameplate are properly attached. Both plates are with imperial units.

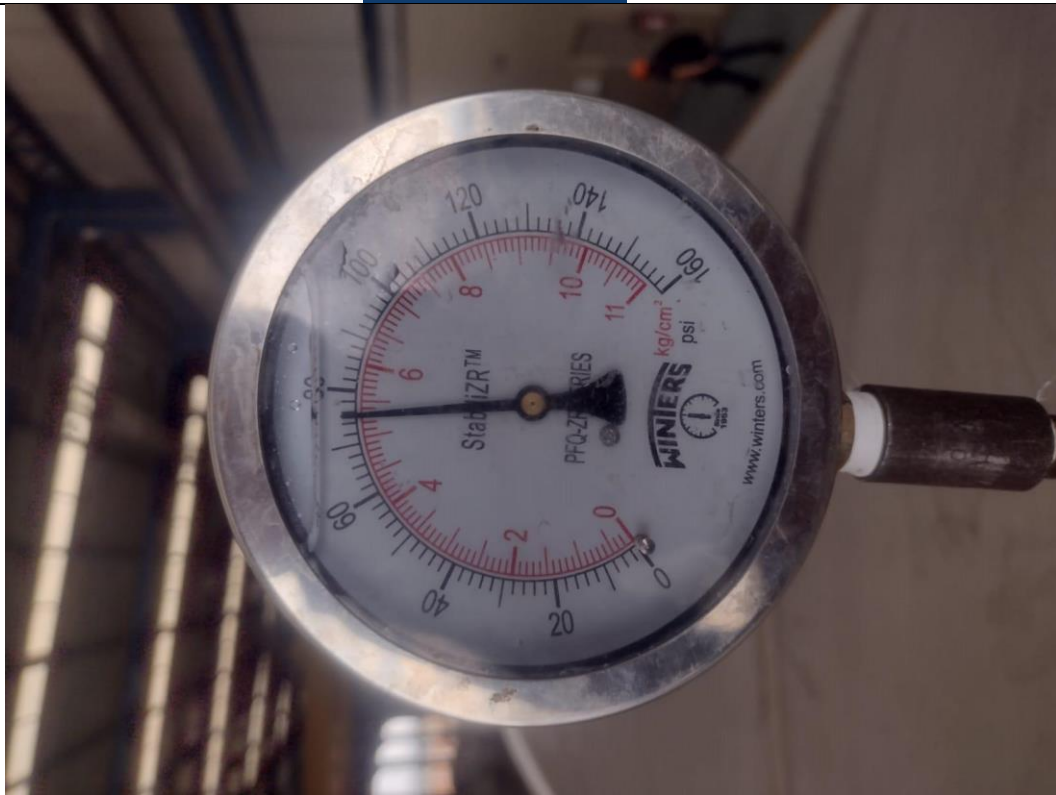
Bleacher was final tested at 76 PSI. No leaks or deformities were detected. The test was also approved by the ASME inspector.
