## **INSPECTION REPORT**

### A. FINAL INSPECTION REPORT: BY RDR

B. Project code : WORPAR  
Workshop : EQUIPROMEX  
Item : W582D.2  
Drawing Nr : ASSY 100191066 Rev04, BODY 100191067 Rev03  
Order Nr : 2729  
PO nr : 2729  
Inspector : RODRIGO DIAZ  
Date : 02/08/2022

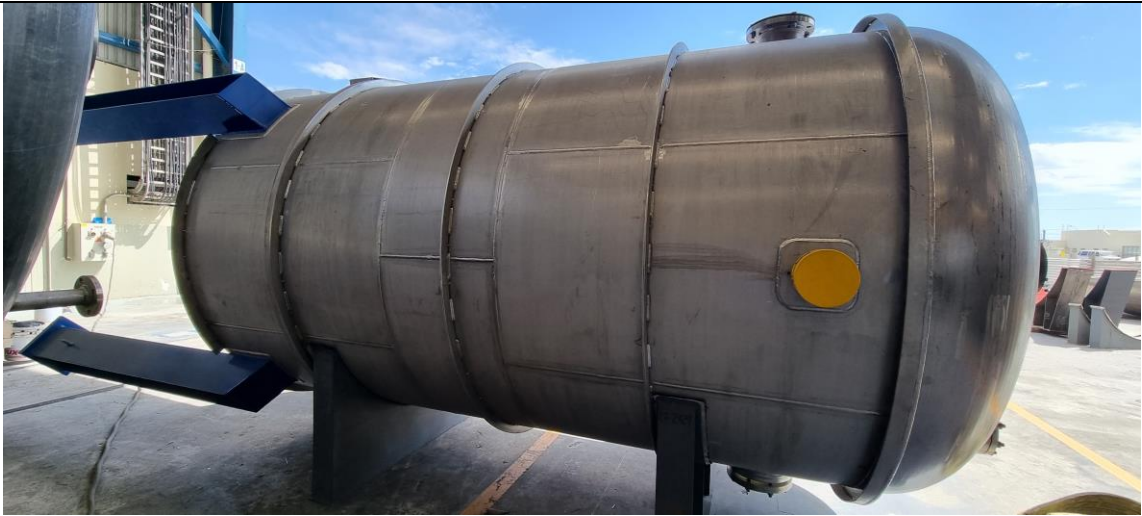
90 degrees view. Oil collecting tank W582D.2 fabrication complete. The final visual appearance of base metal and welding satisfactory. Internal and external cleaning satisfactory. The tank was also inspected by customer's third-party inspector.

Nozzles sealing with blind flanges for long storage preservation are bolted.

The final quality dossier is complete.

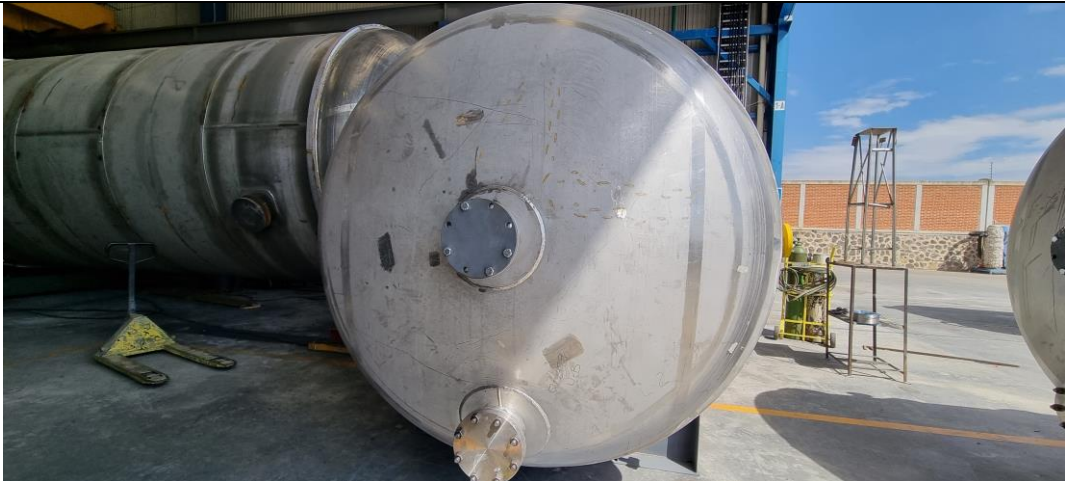
Top view. Verified top dished end thickness after forming is over 3/16".

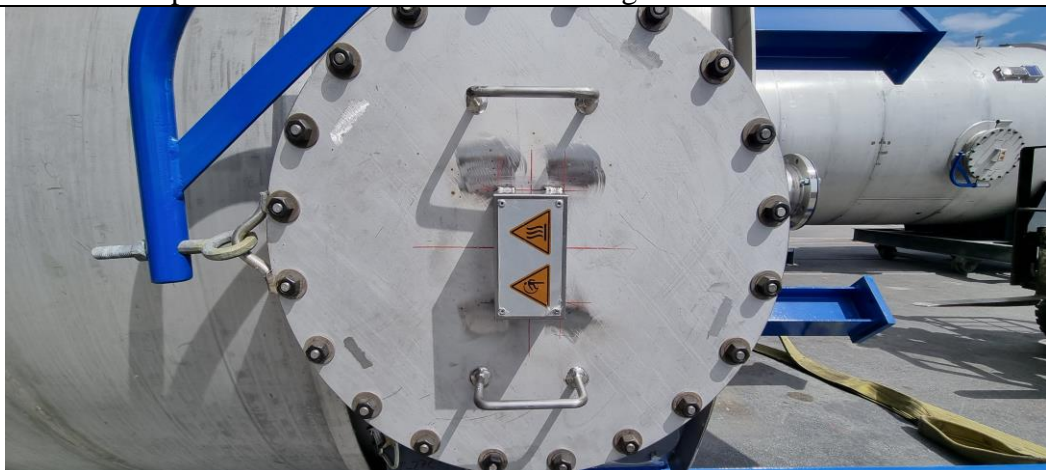
The warning plate was properly changed to type 6.

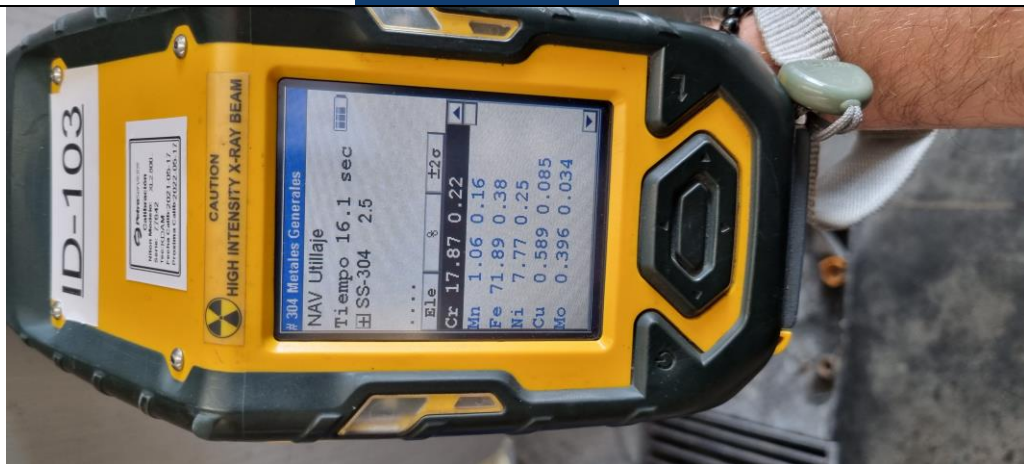
Performed random spot positive material identification test with satisfactory results on material type SS-304 and reviewed Equipromex QC PMI reports with positive results on MOC SS-304 and MOC SS-316 for the coil.
