| DOCUMENT DESCRIPTION | ENZYME REACTOR | PROLJM | PRV | | |

## **INSPECTION REPORT**

### A. FINAL INSPECTION REPORT: BY RDR

B. Project code : WORPAR  
Workshop : EQUIPROMEX  
Item : W503E1.2  
Drawing Nr : ASSY 100174585 Rev06, BODY 100174586 Rev04  
Order Nr : 2743  
PO nr : 2743  
Inspector : RODRIGO DIAZ  
Date : 07/01/2022

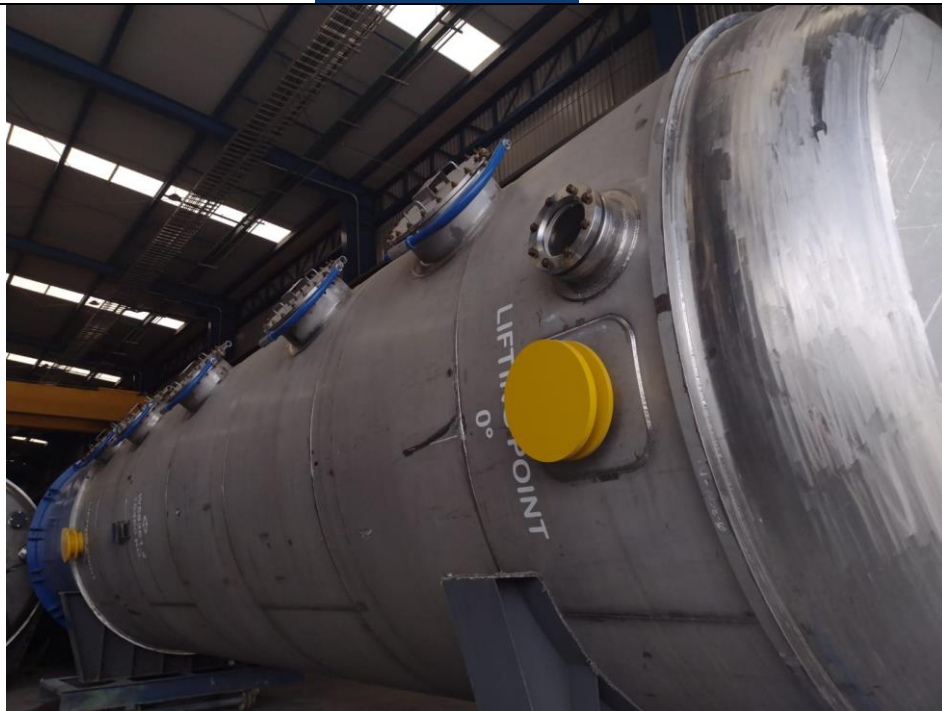
0-degree view. Enzyme reactor W5031.2 (19-RA-854A) fabrication and shipment preparations are complete. Final visual appearance of base metal and welding is satisfactory. The vessel is ready for shipment.

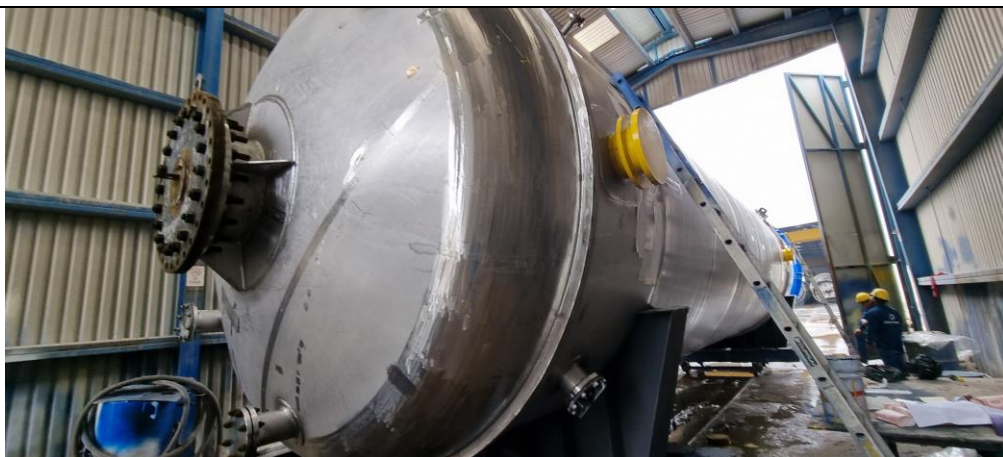
Top dished end. Final visual appearance satisfactory. RX results on the welded seam satisfactory. Thickness after forming is over 1/4".

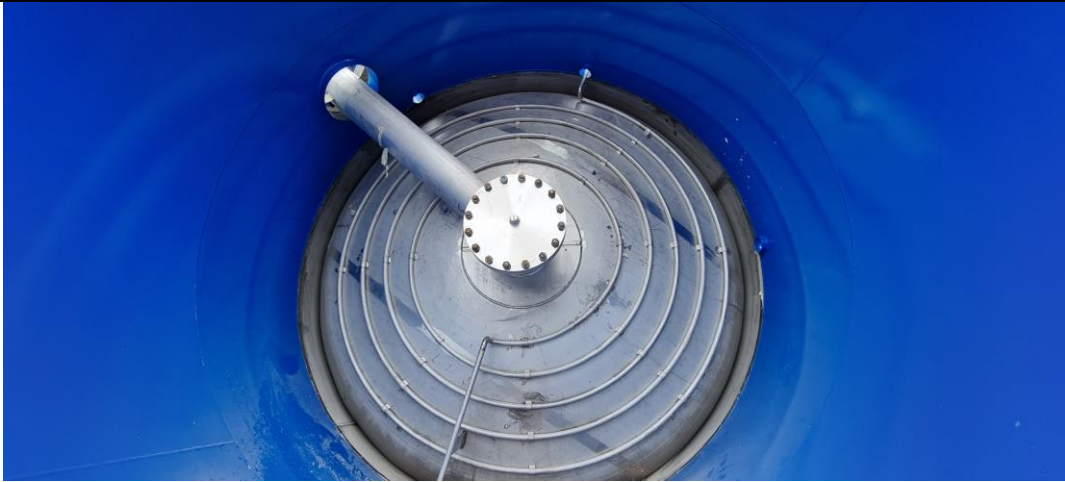
Bottom view. Final visual appearance of coil satisfactory. Coil is properly clamped to the bottom dished end.

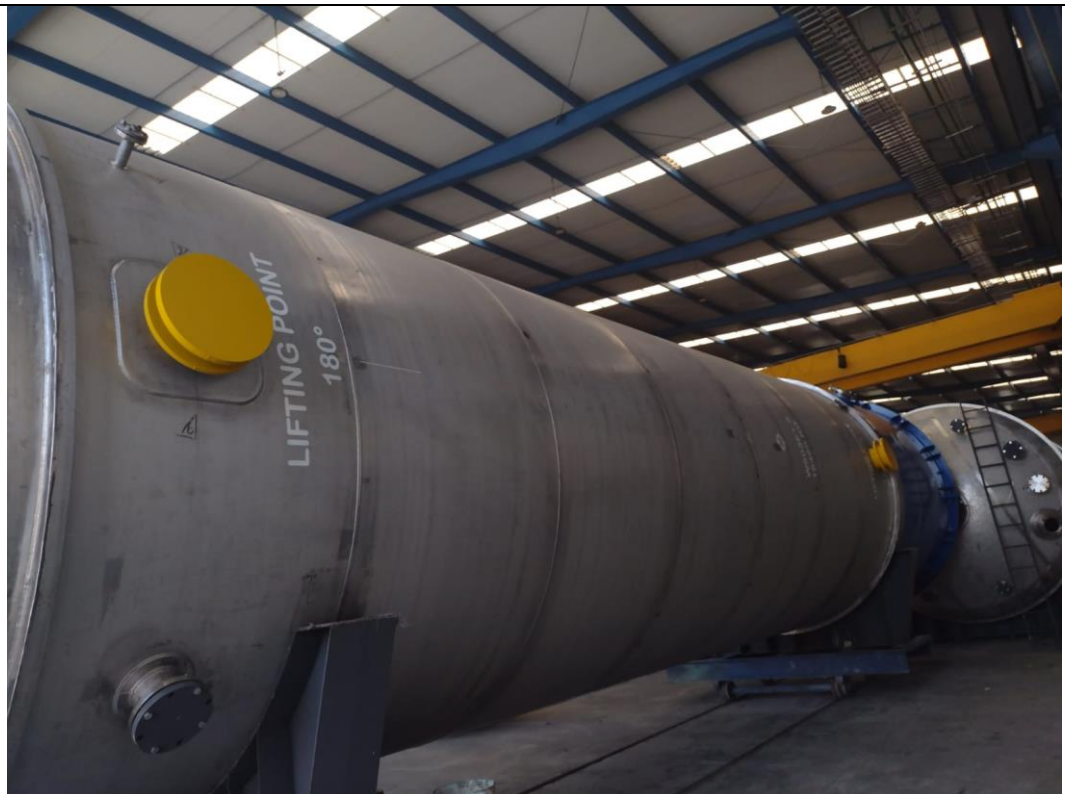
180 degrees view. Orientation and shipment marks are painted.
