API 510 REPORT

95845 Gallon Stainless Steel 4800 Gallon Drum Internal/ External Report

Item: 95845 4800 Gallon Stainless Steel Drum

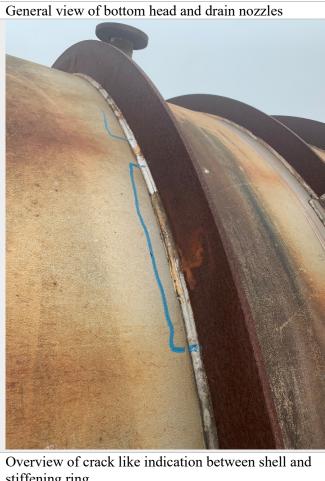
stiffening ring

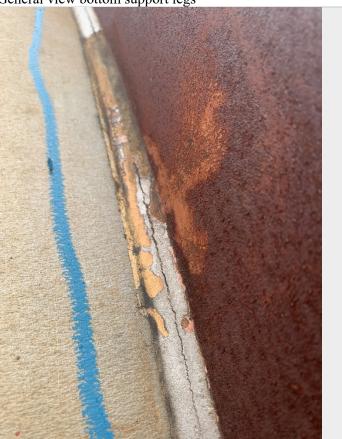
Close up view of crack like indication between the shell and stiffening ring

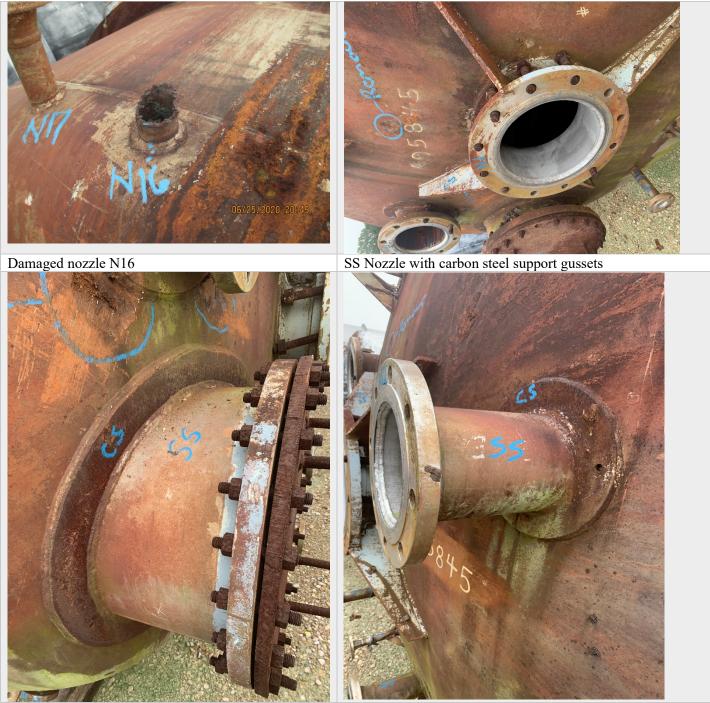
Nozzles on this vessel were seen with no plugging, distortion. Though all nozzles were stainless steel, some had carbon steel repads, and gussets.

SS nozzle with CS Repad

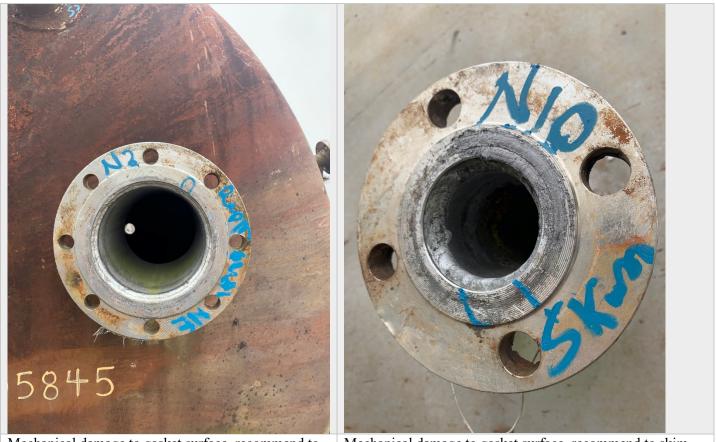
N10	3" SS Nozzle	Mechanical damage to gasket surface	Recommend to skim cut to restore finish	Damaged GSS
N11	³ ⁄ ₄ SS Nozzle	Acceptable	NA	Cleanliness issues

Raised face gasket surfaces on available nozzles were seen to be in good condition with full serrations and acceptable face height with the exception of nozzles- N3, and N10 (Both flange face were mechanically damaged and in need of surface restoration) Most slip flanges have been damaged by arc gouger, consider replacement if used.

Mechanical damage to gasket surface, recommend to skim cut to restore finish
